INVESTIGATION NO. 2726
THE PENNSYLVANIA RAILROAD COMPANY
REPORT IN RE ACCIDENT
AT SHORE, PA., ON
SEPTEMBER 6, 1943

Accident at Shore, Pa., on September 6, 1943, caused by a
broken journal.

Inv. No. 2726
Pennsylvania Railroad
Shore, Pa.
September 6, 1913

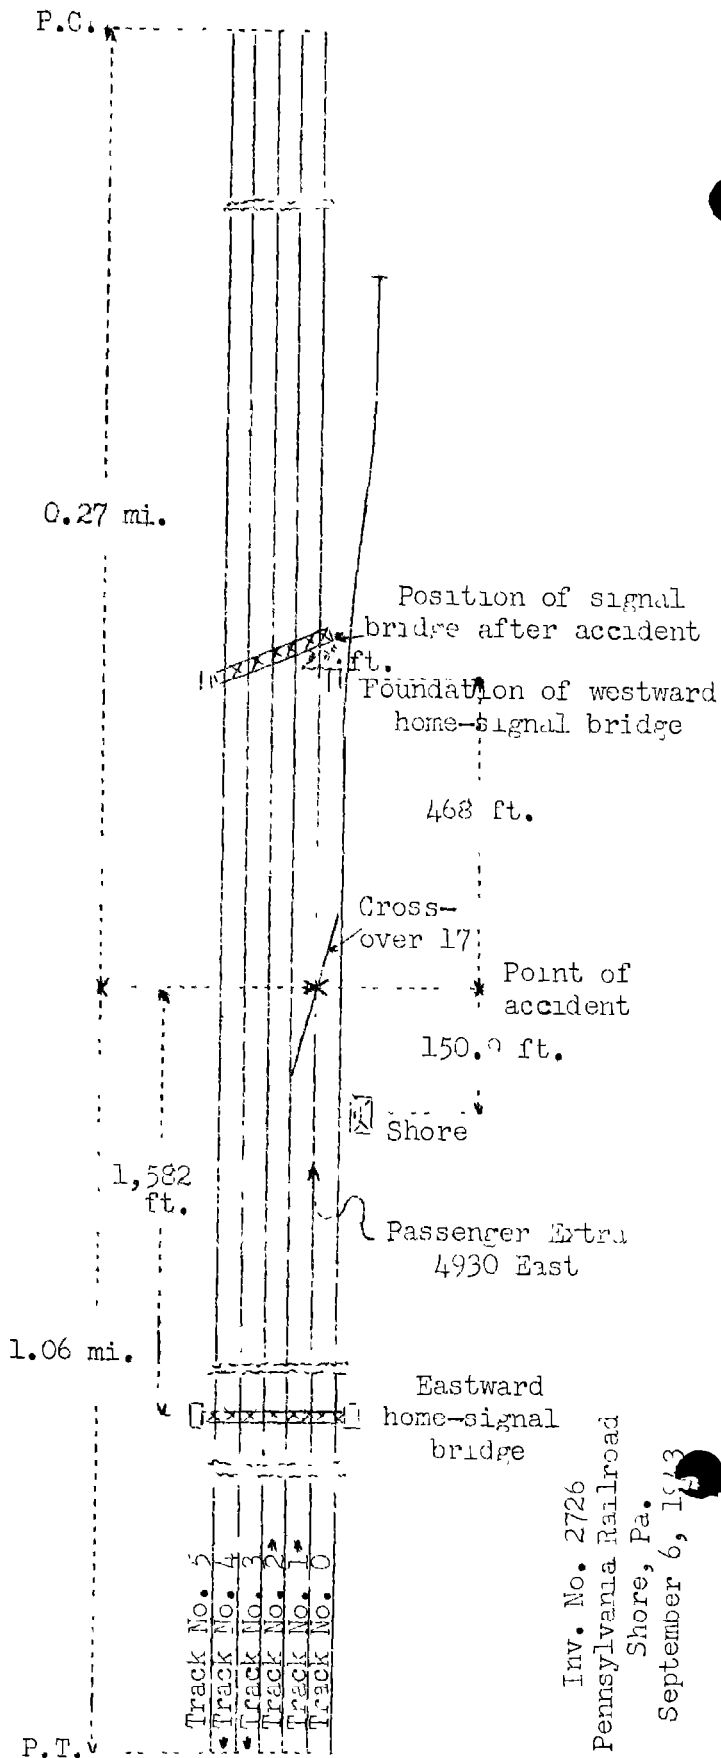
Broken journal
5-1/2" by 10"

After the accident it was found that the left front journal of the front truck of P. R. R. 1860, the seventh car, was broken off. Beginning at the heel of the west frog of the movable-point crossing and extending eastward 23 feet 4-1/4 inches, an angular flange-mark appeared on top of the head of the north rail. Extending from the east end of this mark a distance of 48 feet 8-1/4 inches to the heel block of the east movable point of the crossing, the ties bore wheel marks outside the north rail and inside the south rail. Immediately east of the heel block the track was torn up a distance of 480 feet, and from this point eastward it was damaged 1,056 feet.

point the structure abruptly diverted back approximately to the original. The shallowness of the transformed zone signified that the heating to high temperature occurred very rapidly. In conclusion, the report stated that the immediate cause of the failure of the journal was overheating, but examination and analysis of the axle, wedge and portion of the journal bearing failed to develop anything which would cause overheating.
